Maintenance – and repair manual for RollcarTV-3

ZW99547

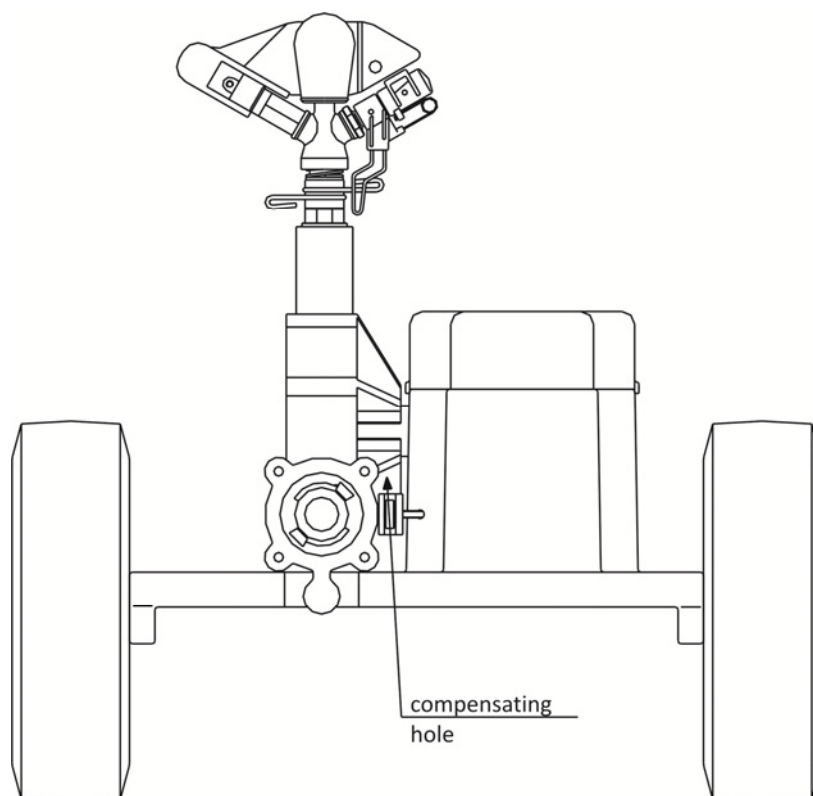
1.1 Leakage on compensating hole

In case there is a recognisable leakage on the compensating hole or in the turbine housing, it must be looked for the reason of the malfunction in the rotary shaft lip seal. In the majority of cases as consequence of the leakage, the deep-groove ball bearing in the turbine housing and partial the deep-groove ball bearing in the gear wheel is damaged (please check leakage monthly).

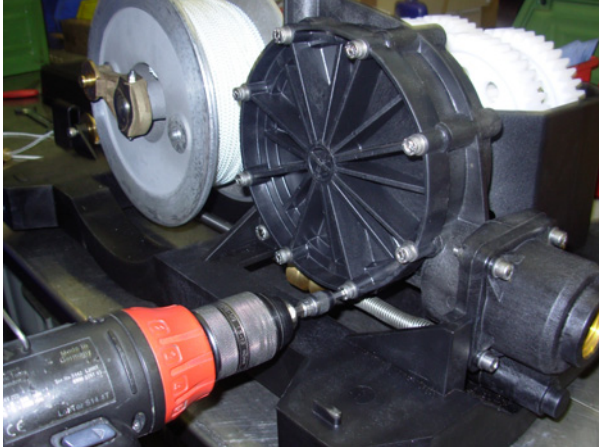
- ⇒ Dismantle bonnet (BT84337), gear box cover (BT84342) and plastic wheel (ZK94434, BT84442, BT84443 and ZK94435) completely.
- ⇒ Screw off turbine covers (BT84419 + ZK94376)

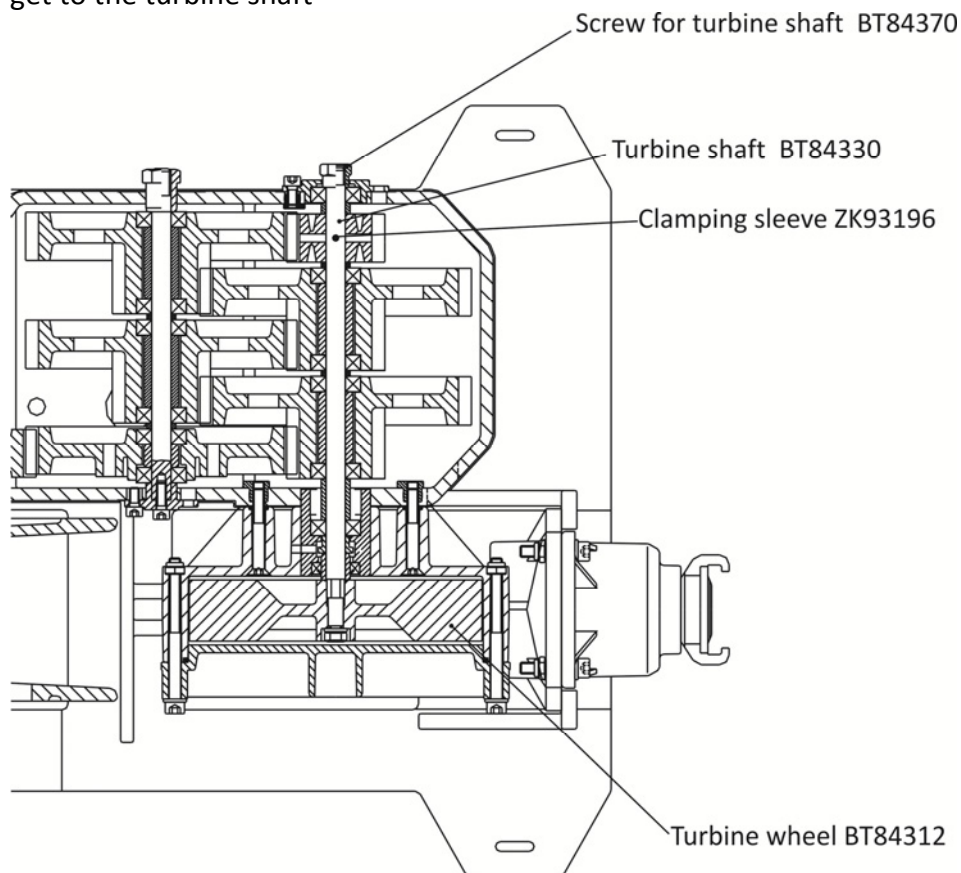
- ⇒ Adhere turbine wheel (BT84312) with the left hand and remove screw (BT84330) M10 to get to the turbine shaft

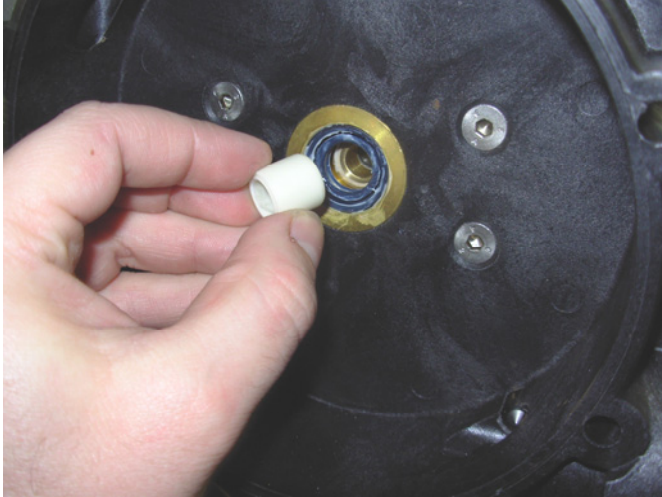
- ⇒ Beat back clamping sleeve (ZK93196) with punch drift 4mm (standard tool).
- ⇒ Pull out turbine wheel (BT84312) with turbine shaft (BT84330).
- ⇒ Pull out sliding bush (ZK94152).

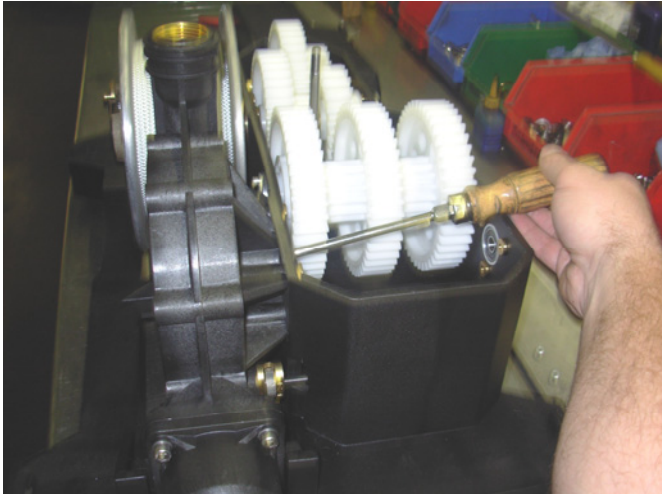
- ⇒ Take out gear and spacer ring off gear case.
- ⇒ Beat out shaft seal packing (ZK94377) together with guide bush for turbine shaft (BT84388).

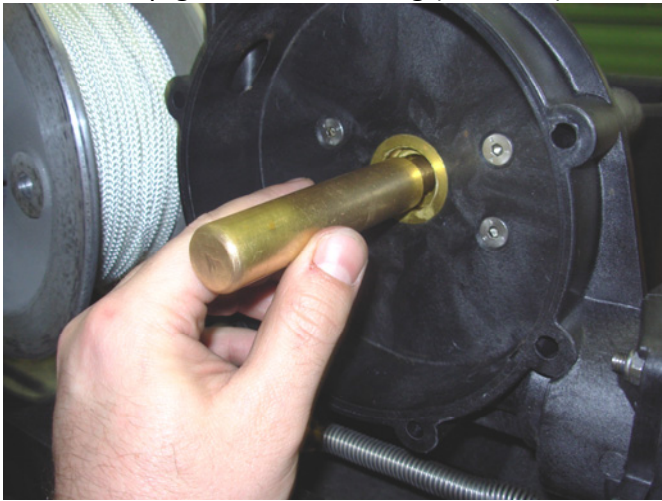
⇒ In case deep-groove ball bearing (ZK94372) is still complete:

drive out with help of pressure bolt No.1 (BT84431) to gear case.

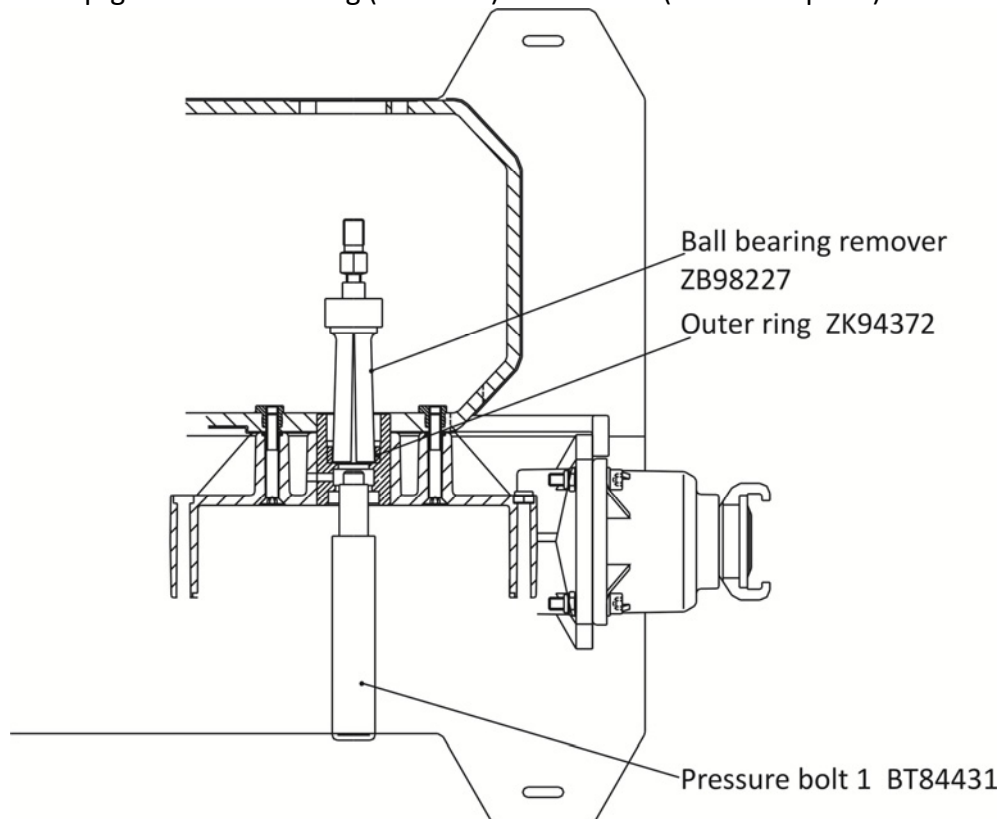
⇒ If deep-groove ball bearing (ZK94372) is defective (individual parts):

Apply internal extractor $\varnothing 19-24$ and strike through with help of pressure bolt No.1 (BT84431) towards gear case.

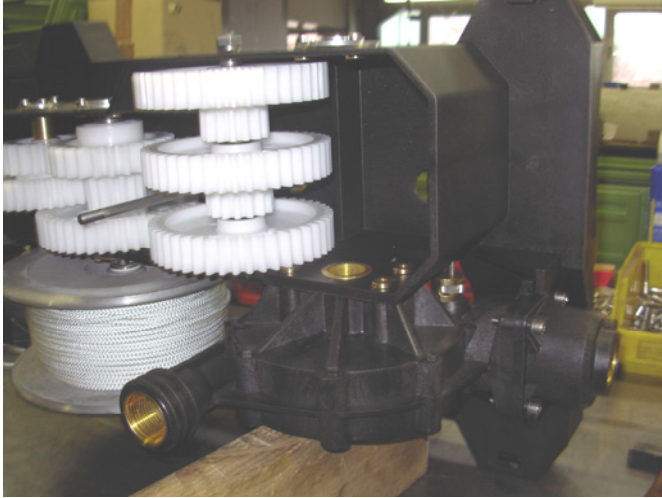
⇒ Set up housing edgewise and inferior

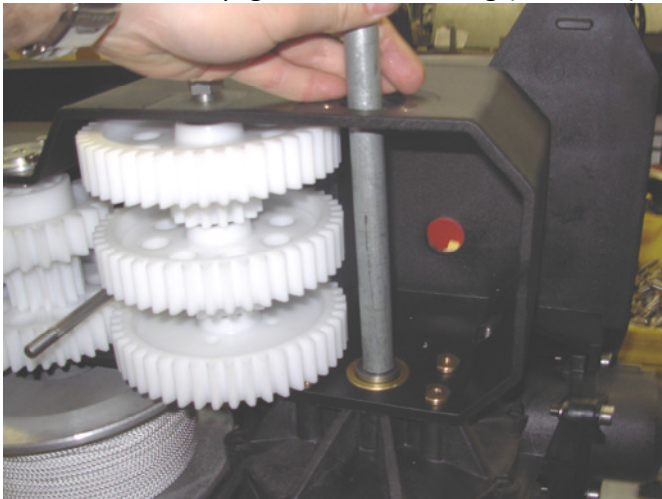
⇒ Press in new deep-groove ball bearing (ZK94372) with pressure bolt no. 2 (BT84432)

Press on deep-groove ball bearing only over outer ring!

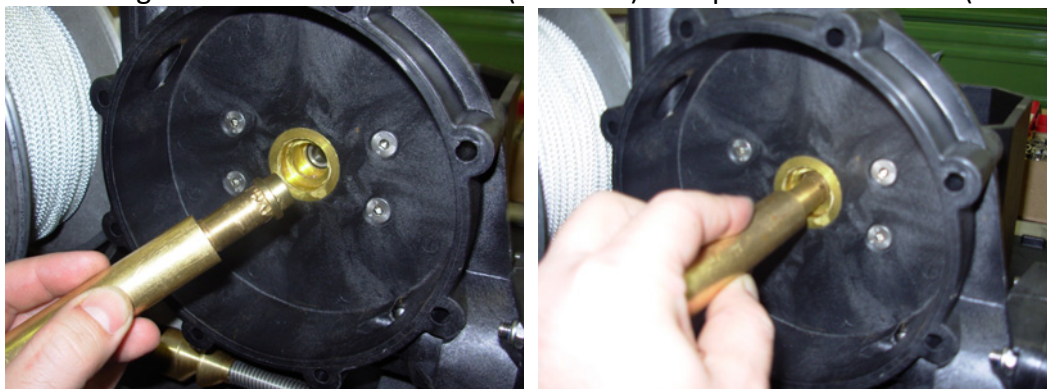
⇒ Insert new guide bush for turbine shaft (BT84388) with pressure bolt no. 1 (BT84431)

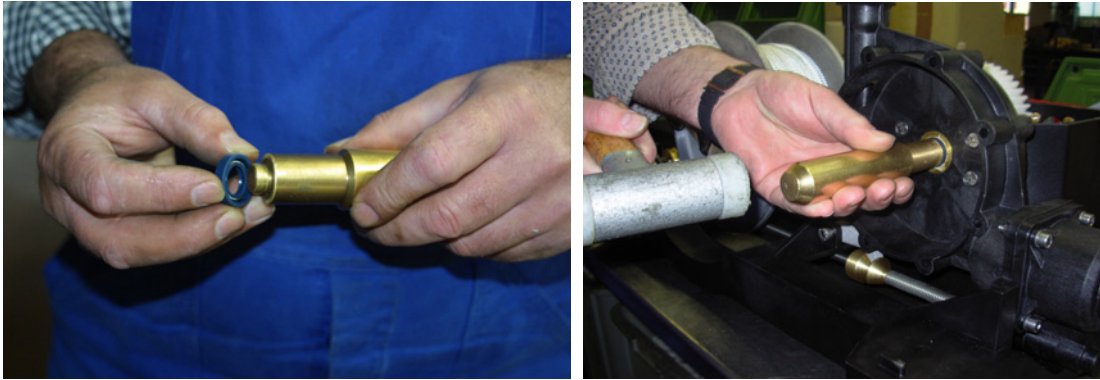
- ⇒ Insert new shaft seal (ZK94377) with pressure bolt no. 3 (BT84433) – opening has to be visual outside

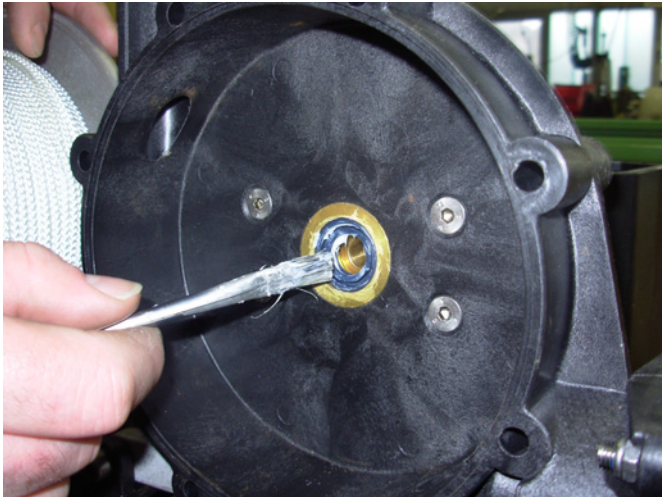
- ⇒ Lubricate rotary shaft lip seal with acid free grease (Molikode)

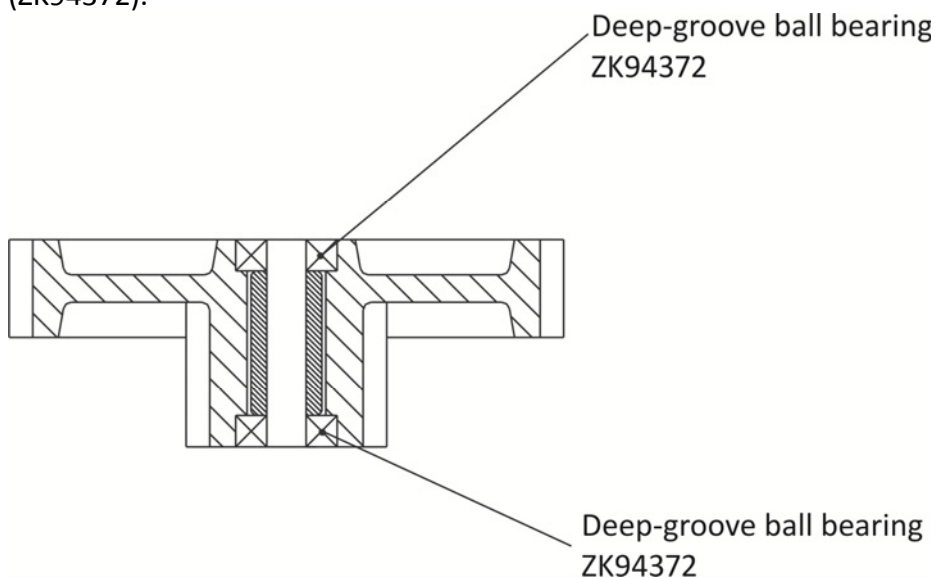
- ⇒ Check the assembled ball bearings on zero clearance and ease of movement in the gears and the cover turbine shaft, if necessary replace it by a new deep-groove ball bearing (ZK94372).

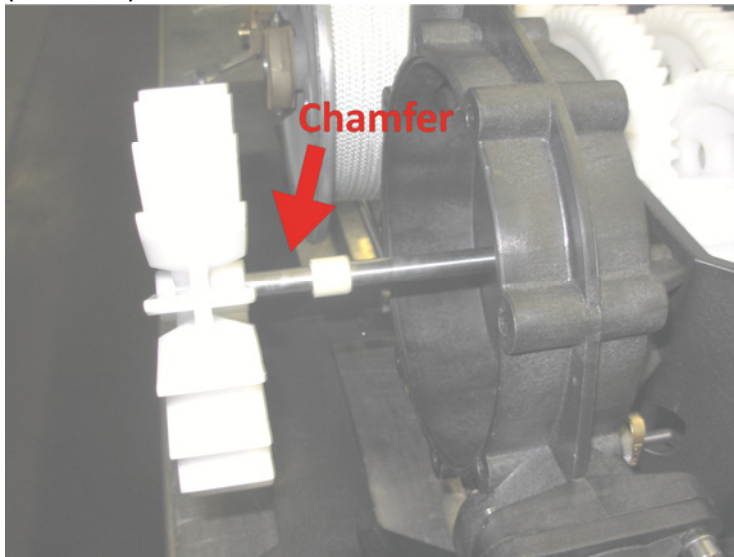
⇒ Insert and ensure correct position of turbine shaft and turbine wheel with sliding bush (ZK94152)

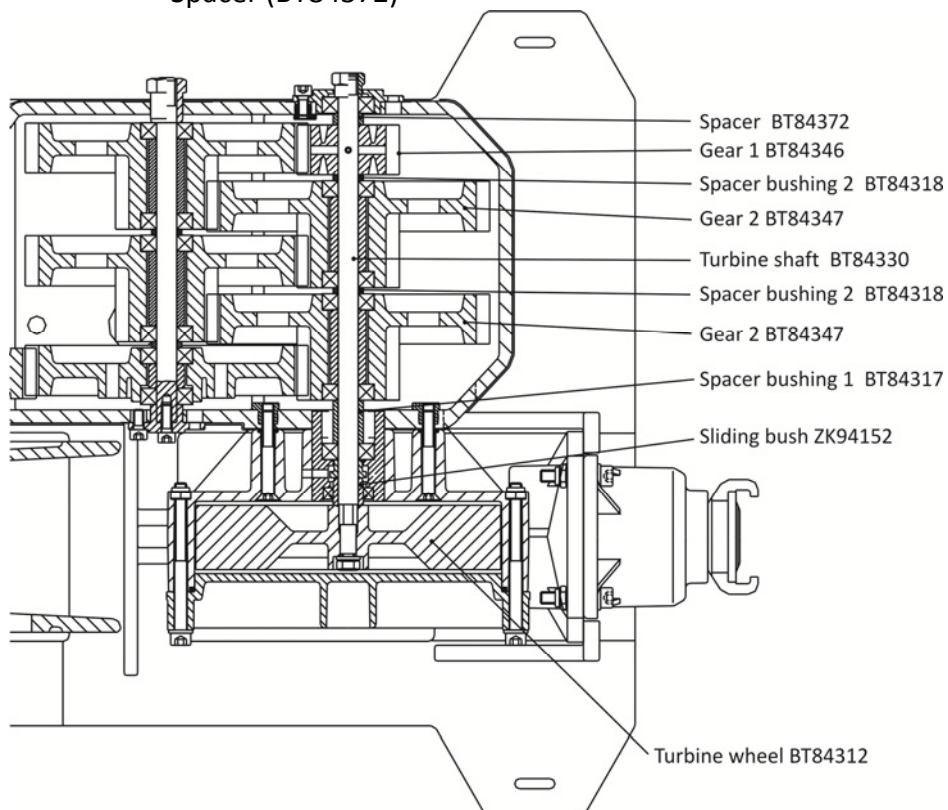
bead than following pieces on turbine shaft:

- ☆ Spacer bushing 1 (BT84317)
- ☆ Gear 2 (BT84347)
- ☆ Spacer bushing 2 (BT84318)
- ☆ Gear 2 (BT84347)
- ☆ Spacer bushing 2 (BT84318)
- ☆ Gear 1 (BT84346)
- ☆ Spacer (BT84372)

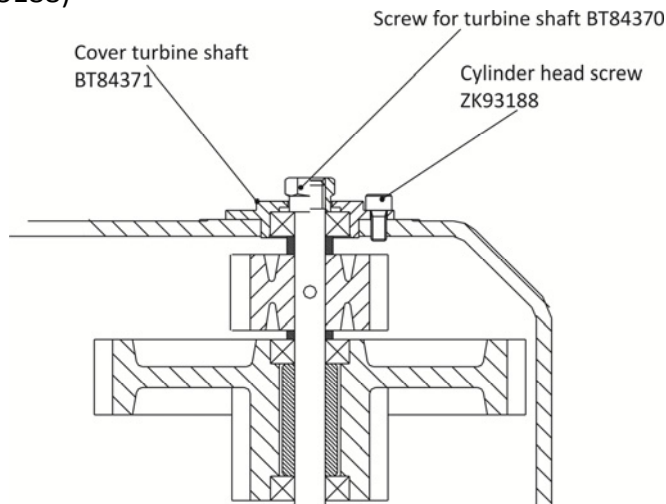
- ⇒ Screw tightly cover for turbine shaft (BT84371) with deep-groove ball bearing (ZK94372) (3x ZK93188)

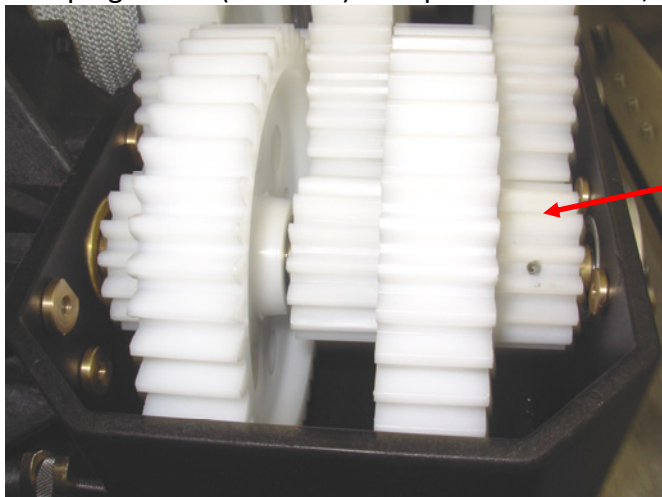
- ⇒ Turn turbine shaft and gear 1 in that way that the bore holes are congruent. Drive into clamping sleeve (ZK93196) with punch drift 4mm, deeper than the dedendum.

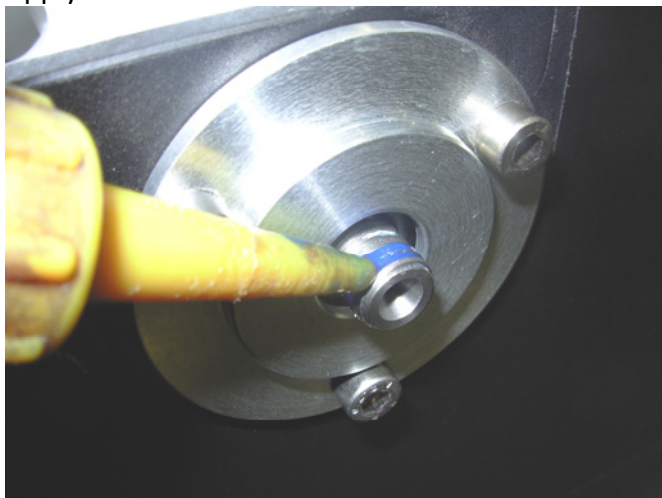
- ⇒ Apply blue Loctite on thread of turbine shaft

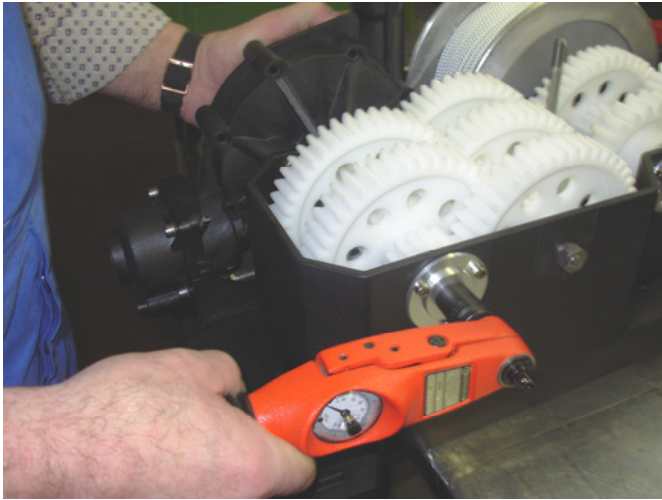
⇒ Unscrew clamping nut for turbine shaft (BT84370), adhere turbine wheel with the left hand and tighten net with 9-10Nm.

If the clamping torque is too small a leakage on the turbine shaft arises; thereby the deep-groove ball bearing is destroyed.

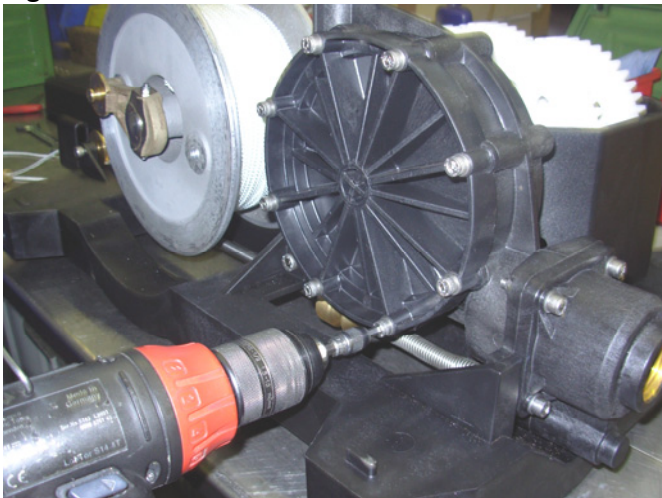
⇒ Tighten turbine cover

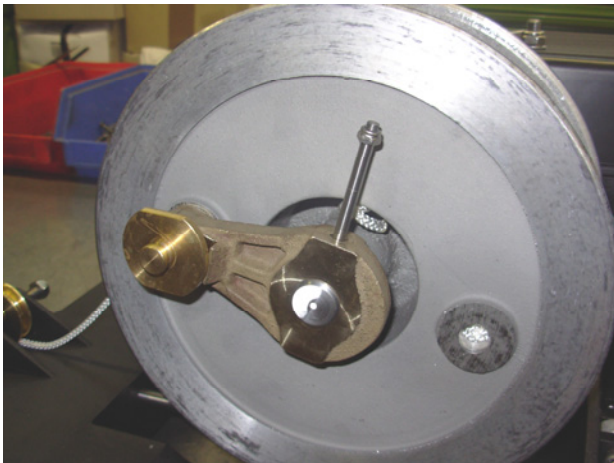
Remove nuts from shearing screw BT84336 and beat through shearing screw through the shaft.

- Pull down driver BB84341 from the shaft.

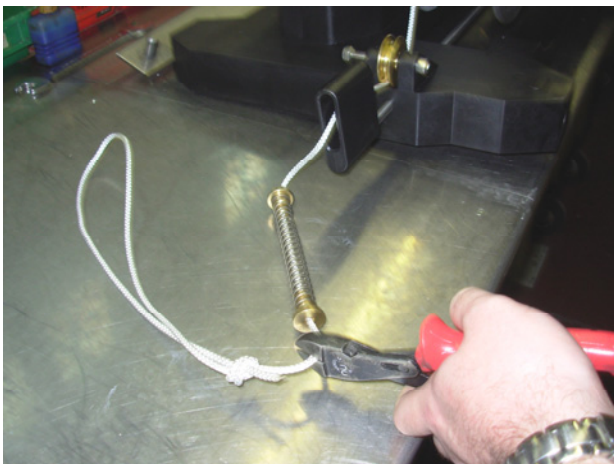
- Cut cable so that the limit stop for RollcarT (BT84416 and ZK84424) can be deducted from the cable.

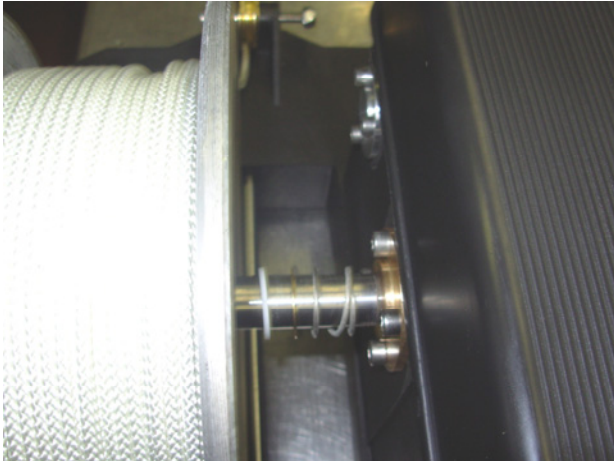
- Deduct cable drum from the shaft and replace it by a new cable drum BB84429.

Ensure that spring, brass washer and Teflon washer (drum brake) are fitted before putting on the cable drum!

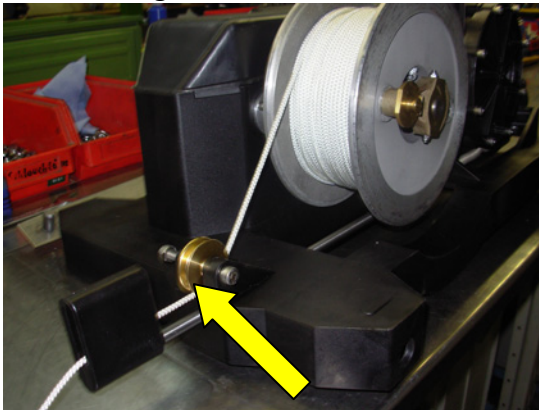
cable guide

- Feed hauling cable into cable guide, shut-off rod and limit stop. Form a loop at the end and knot together.

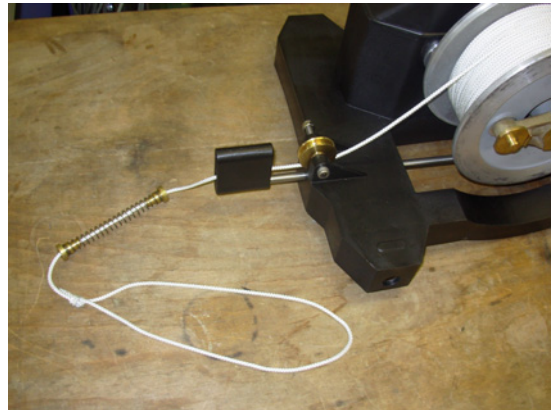
Make sure that the loop goes over the spur!

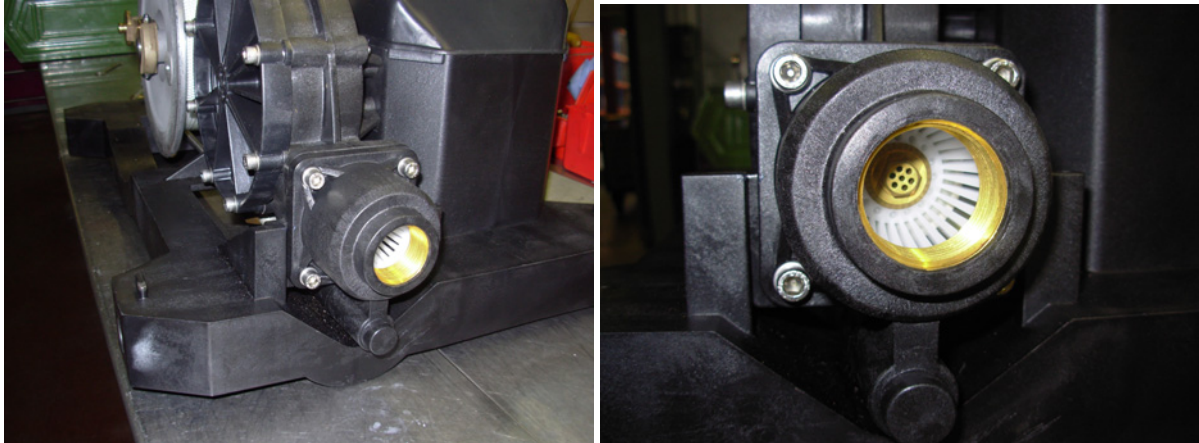
After every watering job, an easy check can be made to see if the valve is watertight. Especially when using uncleaned water, it can happen that the valve may fail to close or open completely. Small stones, for example, or grass may also have become stuck in the valve, which would result in the sprinkler losing pressure.

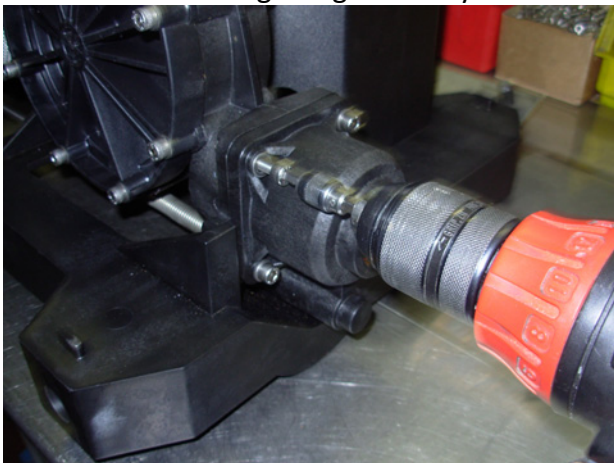
- Remove valve casing using Allen key SW5

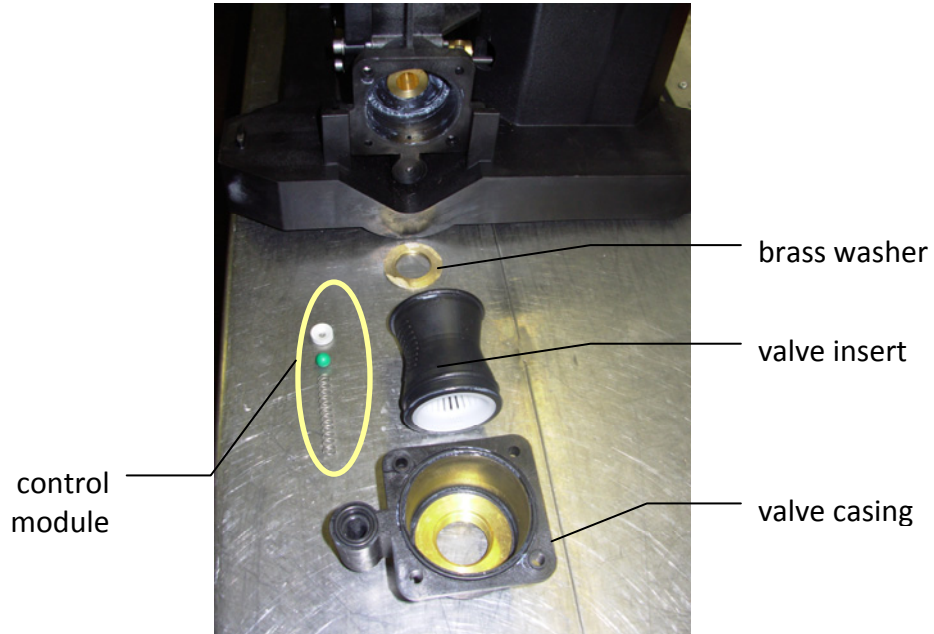
- Clean valve assembly and check for damage

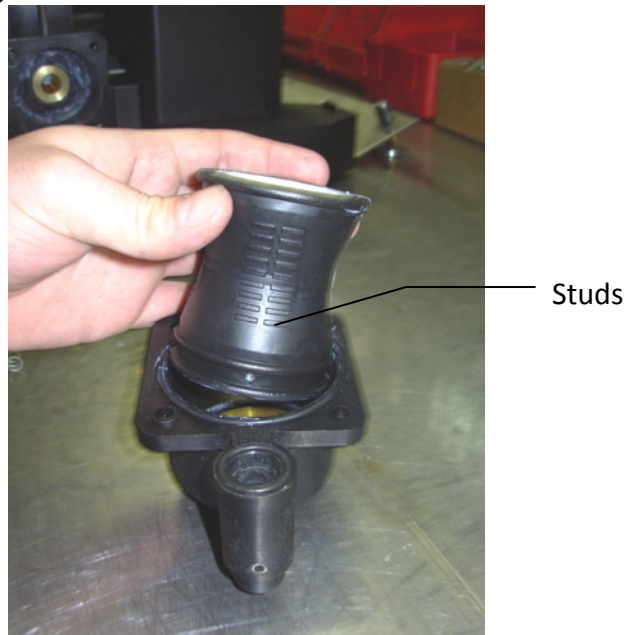
- When putting the valve back together, ensure that the valve insert is fitted with the studs facing down

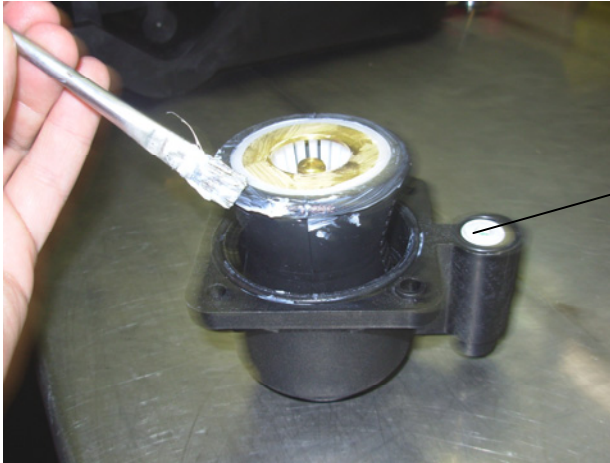
- Assemble control module (1st spring, 2nd ball bearing, 3rd seal), as per detail X on the individual parts list
- Insert brass washer with chamfer facing the valve insert
- Smear valve insert with non-acidic grease (Molykote) and put back together

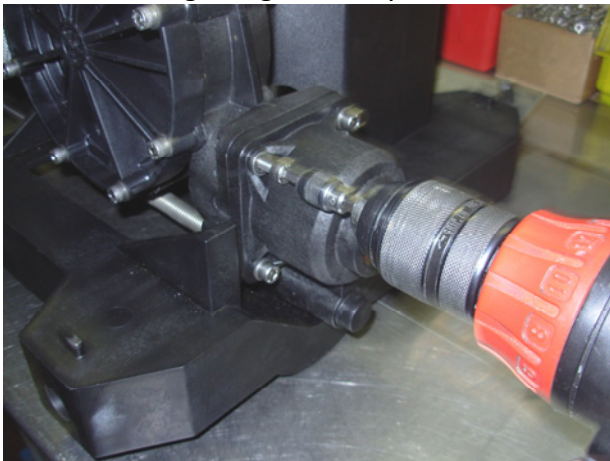
- Fit valve casing using Allen key SW5
